Dawson Tool-Less Guide-Rod Problem's Updated

On Brian Enos Forum 2005: Dawson was making Tool-Less Guide-Rods

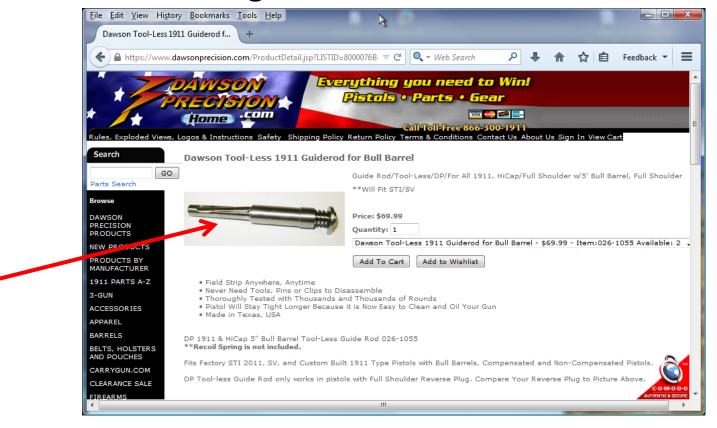
WebPage Info.

DP 1911 & HiCap 5" Bull Barrel Tool-Less Guide Rod 026-1055 **Recoil Spring is not included.

Fits Factory STI 2011, SV, and Custom Built 1911 Type Pistols with Bull Barrels, **Compensated** and Non-Compensated Pistols.

DP Tool-less Guide Rod only works in pistols with Full Shoulder Reverse Plug. Compare Your Reverse Plug to Picture Above.

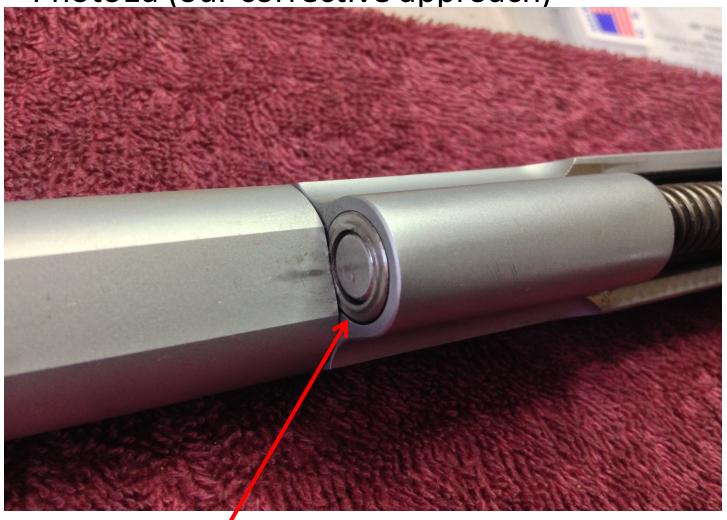
Photo1a (our corrective approach)

Rim removed to Fit behind compensator in GM #910

When trying to insert the DP Tool-Less Guide-Rod into my #910 Grand Master, we noticed the end of the plug raised rim, prevented the compensator from fitting correctly. See Photo1a where the raised rim was removed.

When I inserted my first DP Tool-less Guide-rod into GM#910, we found the **Rim** on the cap did not allow the compensator to fully seat. We had to reduce The rim on the cap or plug whatever the correct name is. See Photos herein.

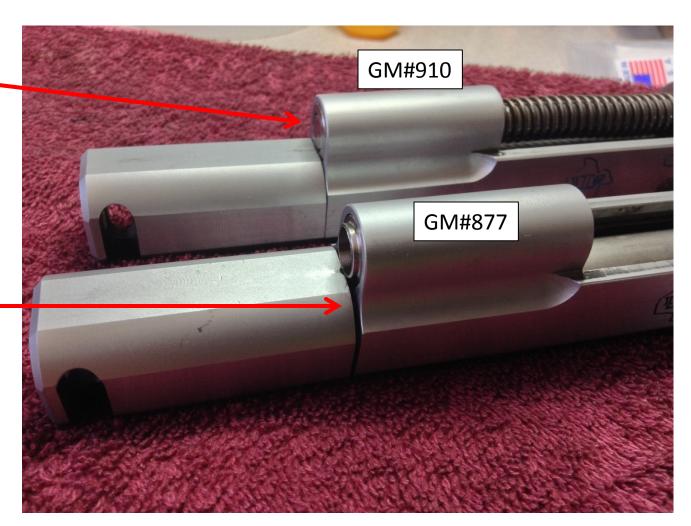
Photo2a (The two GM are not the same.)

Rim removed to
Fit behind compensator
In GM# (910)

Rim of plug prevents Compensator going Back into gun In GM#(877)

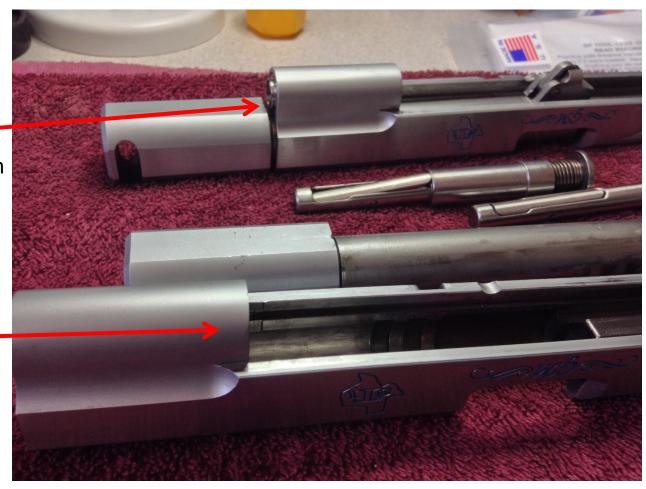
Photo3a (the GM recoil hoods are different)

My second DP Tool-Less Guide-Rod would fit into GM# (910) but the rim Causes problems as noted.

My first DP Tool-Less
Guide-Rod would **not** fit
into GM# (877)

My second DP Tool-Less Guide-Rod would **not** fit into GM# (877)

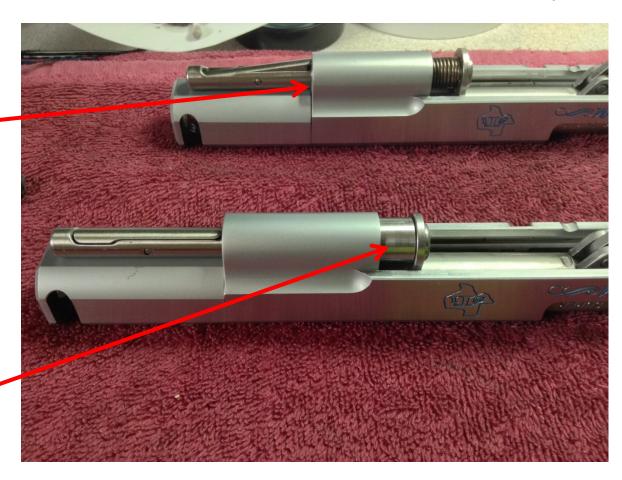
Photo4c (Where the hoods are difference & touches)

My first DP Tool-Less
Guide-Rod would fit
into GM# (910) after
Removing the front rim.

My second DP Tool-Less Guide-Rod would **not** fit into GM# (877). It would stick at this position.

When trying to insert the DP Tool-Less Guide-Rod into my #877 Grand Master, Both tool less guide rods will not fit under the slide front housing. See Photo4c.

After calling Houston, I learned Dawson was aware of the DP Tool-less guide-rod problem with the GM. Their position is STI does not watch the tolerance in the tunnel portion of the slide. This was a known problem with STI's. They offered to make me two new DP Tool-less guide-rod and would send them to me.

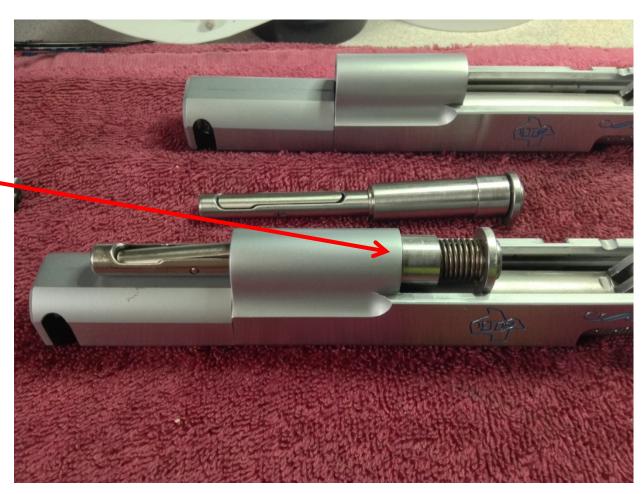
Photo4d (Where the hoods are difference & touches)

My first DP Tool-Less Guide-Rod would **not** fit into GM# (877) It would also stick at this position.

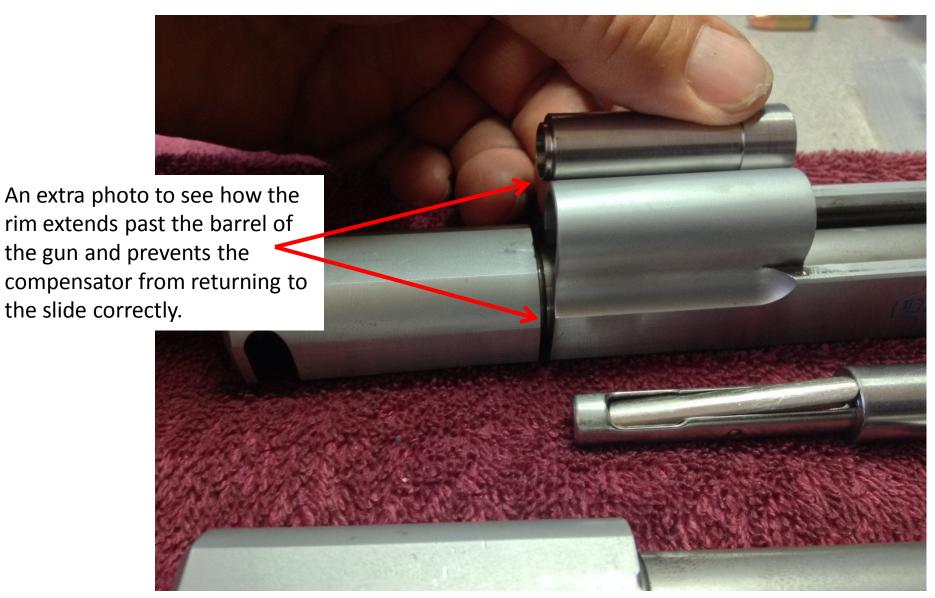
Photo3b

In summary, the two STI Grand Masters I purchased from Dawson Precisions are not as identical as one would think.
